# Runway Surface Condition Assessment and Reporting

## History Behind FAA Friction Level Classifications

By: Raymond Zee, PE, Civil Engineer

Airport Engineering

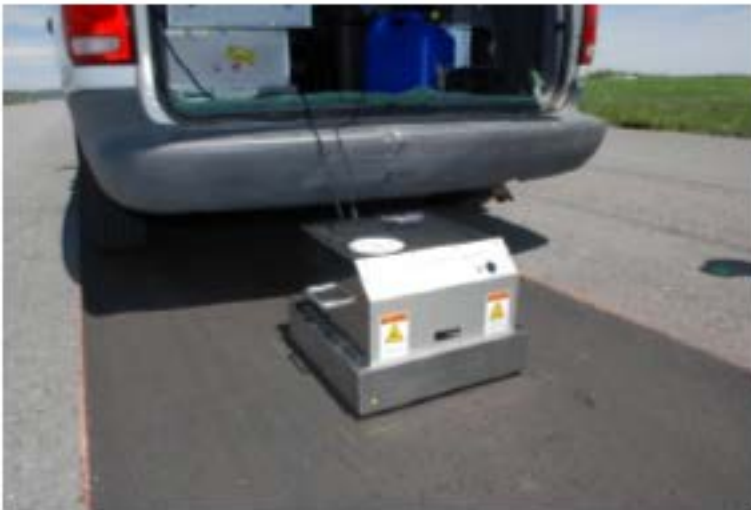
CTM

- **Test Surface mu based on correlation to texture equipment.**

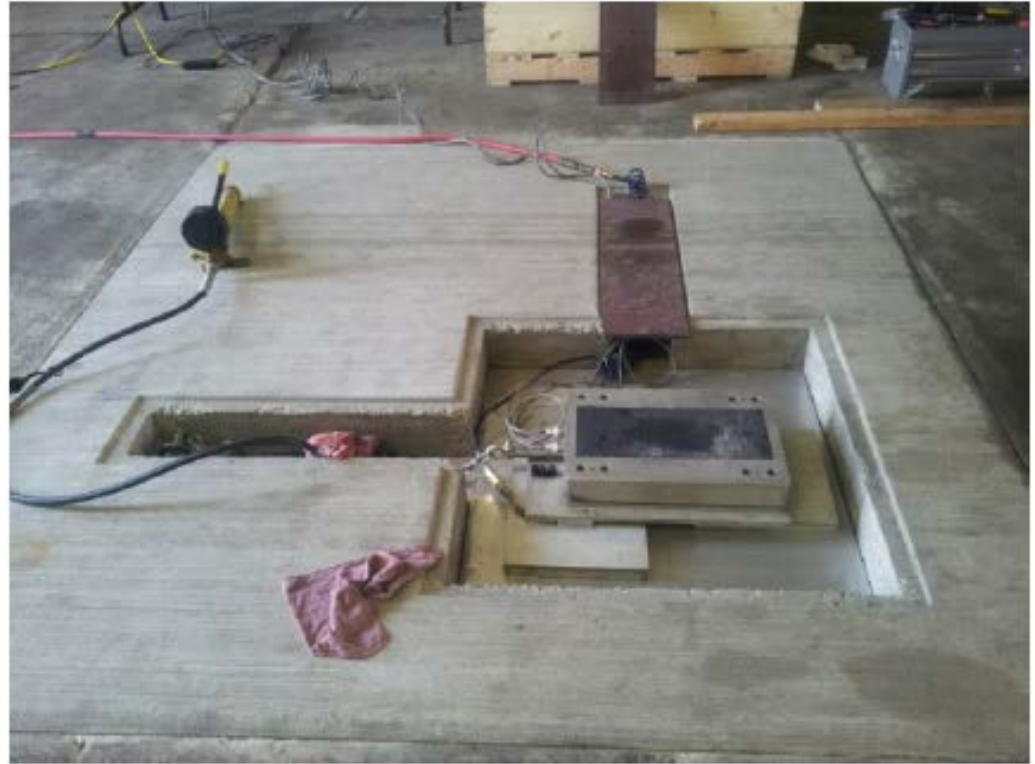
- Vertical load on the plate should match load recorded on the CFME.
- Horizontal loads (longitudinal and lateral) should match forces recorded on the CFME.

Figure 12. Force Calibration Pit and Platform

**Force (Load) – independent verification that the equipment is reading the load on the wheel.**

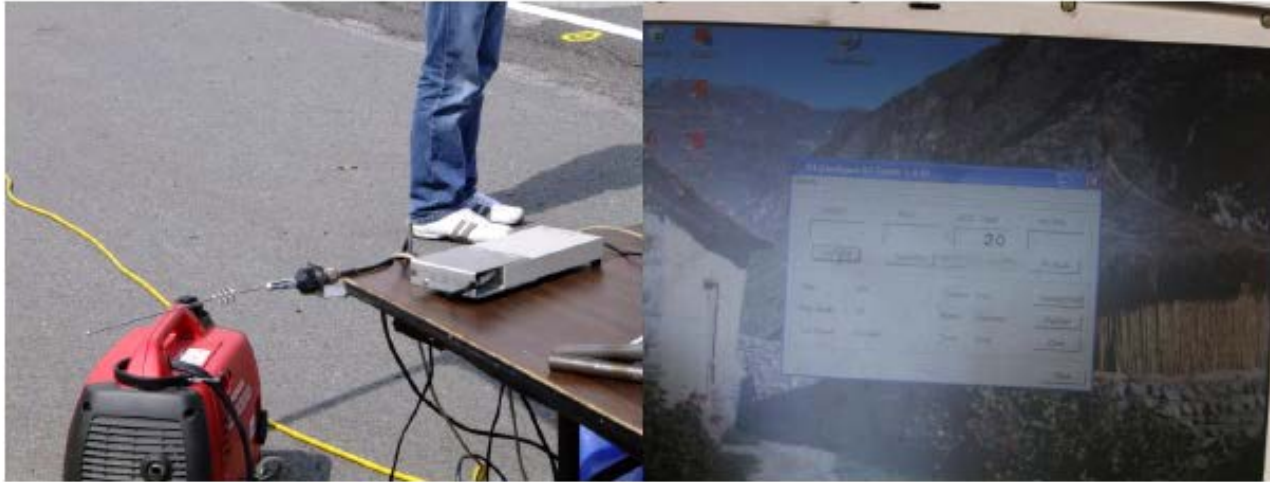
Figure 17. STALKER radar system and display used for speed calibration station.

**Speed – easy to verify – radar gun.**

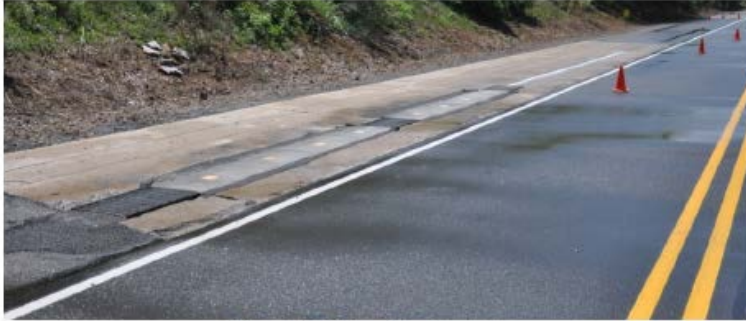
Figure 13. Water calibration station.

**Water (1mm) – how do we know that the system is putting down 1mm of water in front of the test tire?**

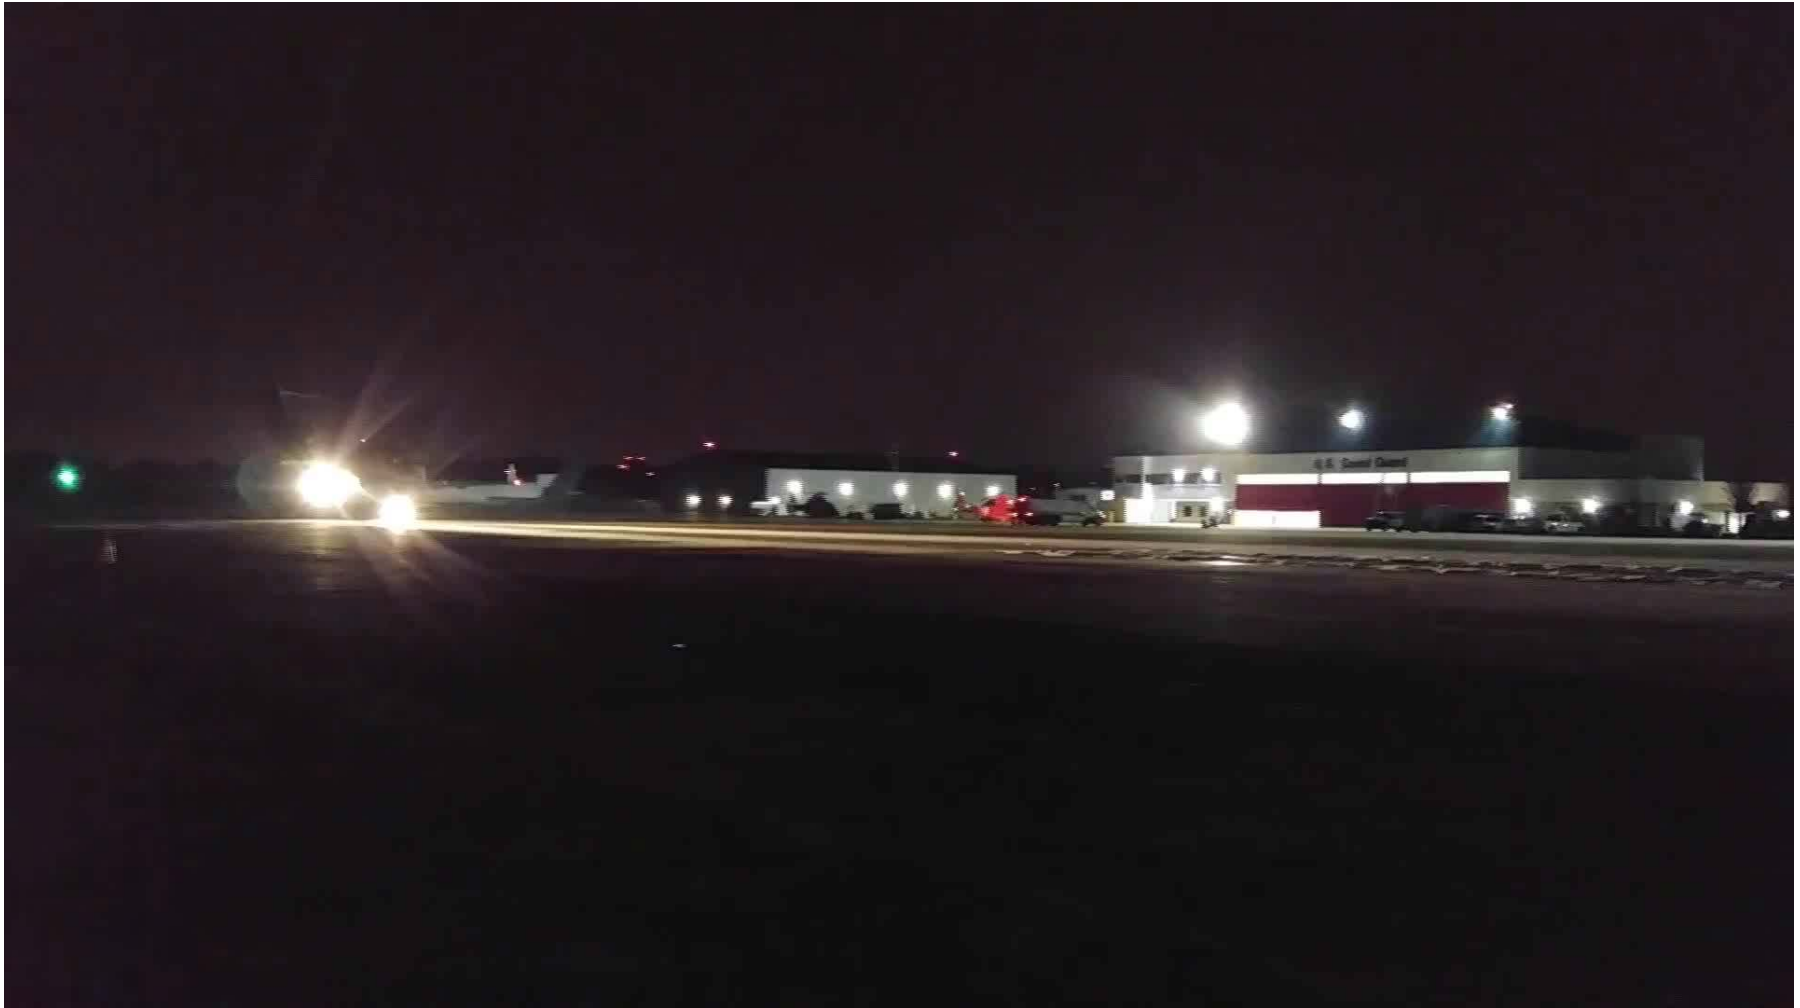
# Aircraft Braking Dual Test Strip

- **Shift to aircraft braking mu and braking on contaminants.**
- **Utilization of data from landing aircraft to provide almost real-time braking mu.**
- **Investigating the relationships between the aircraft ABS, contaminants, and brake line pressures.**
- **Nose and main gear instrumented 727 at FAA Tech Center in Atlantic City, NJ.**
